Field Safety Notice

MR systems with SW versions R11.1 and R12.1
MobiView cross reference alignment errors

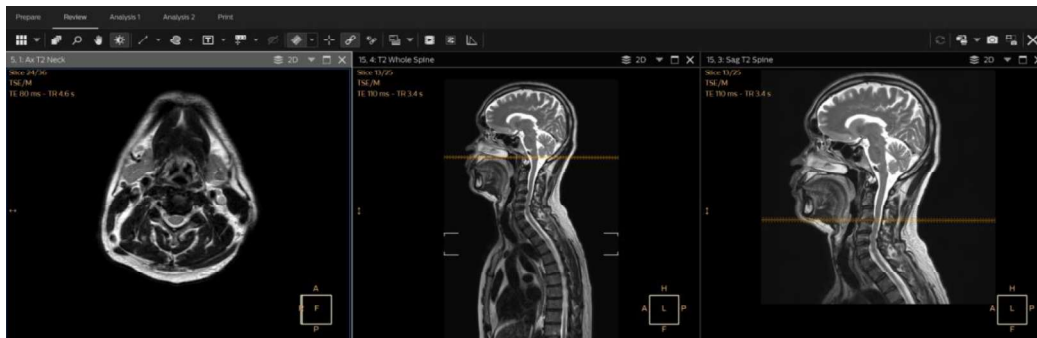
- A. The cross reference line and/or box may be shown at an incorrect location when displayed on a MobiView generated image (see examples in Figure 1 and 2).

- Multi-station scans that require stitching 3 or more station images, and
- Scan protocol is used where stations have different voxel size or field of view (i.e. voxel size or field of view is customized based on anatomy per station).

Figure 1. Cross reference line of the axial image (left) is at the incorrect location on the MobiView generated image (middle). The correct location is shown on the non-fused sagittal source image (right).

- You may continue to use your system(s) in accordance with the intended use.
 - A. To avoid the potential issue of an incorrect cross reference line in MobiView generated images, use the same voxel size and field of view across all station scans.

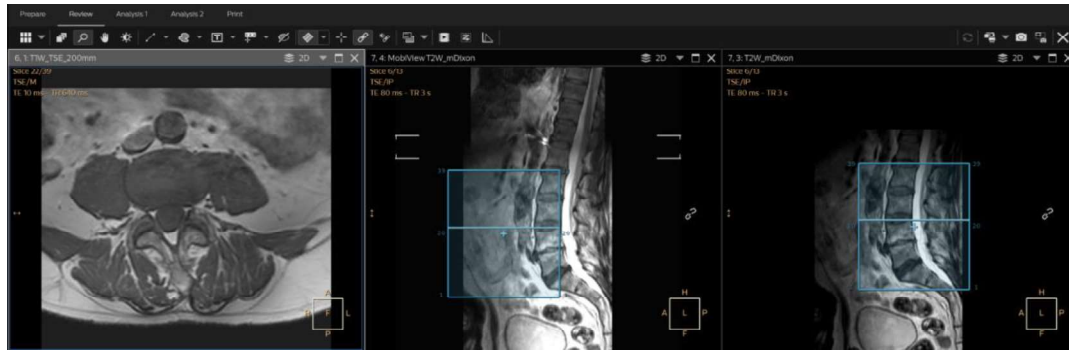
Figure 2. Cross reference box of the axial image (left) is at the incorrect location on the MobiView generated image (middle). The slice position in the box is correct, while the box off-center is incorrect. The correct location is shown on the non-fused sagittal source image (right).

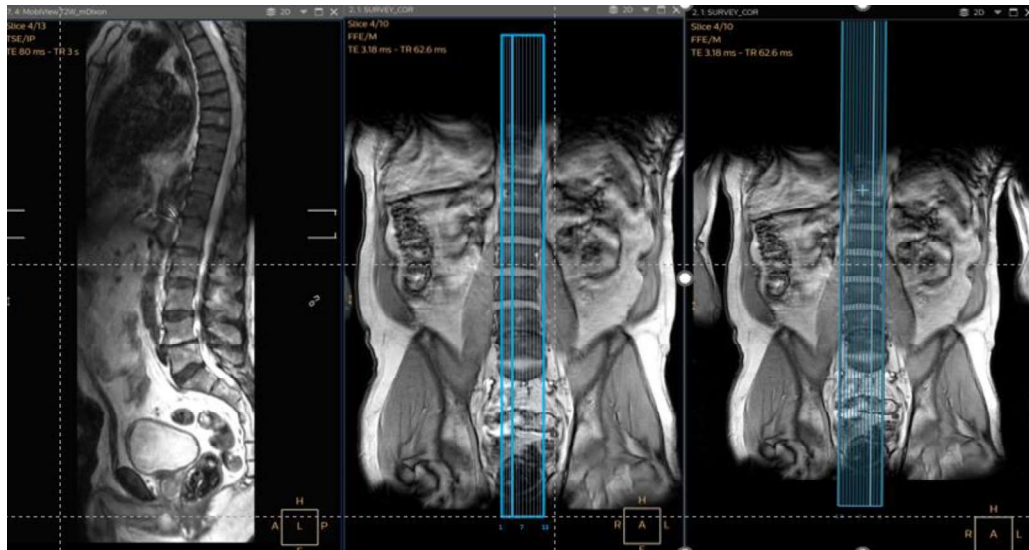
- B. The cross reference box of a MobiView generated image may be shown at an incorrect location when mirrored on to another image (see examples in Figures 3 and 4), if:
- the MobiView images are acquired with reversed slice scan order (i.e. image display settings are customized), or
 - displaying the cross reference box of a MobiView generated merged series (axial stations), or
 - displaying the cross reference box of multi-planar reformats generated from multi-stack data.

Figure 3. Cross reference box of a MobiView generated image with reversed slice scan order (left) is mirrored on another image (middle). The box position is correct, while the slice position and slice numbering are incorrect. The correct location is shown for a MobiView generated image with default slice scan order (right).

- B. Do not use cross reference line functionality in box mode, all slices mode, or 3D mode. Use the cross reference line functionality in single slice mode.

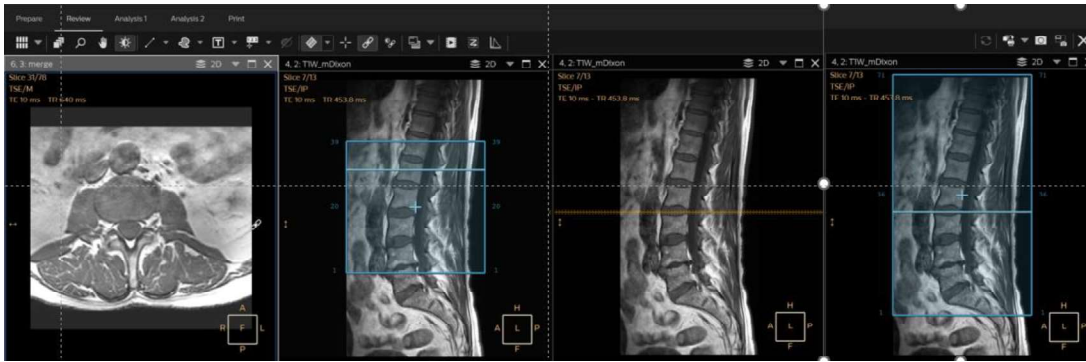
Figure 4. Cross-reference box of a MobiView generated axial merged series (left) displays with incorrect size and location on another scan (mid-left). The cross-reference line of the same MobiView generated axial merged series is at the correct location (mid-right). The correct box size and location is shown for a Mobiview generated axial fused series (right).
