URGENT – FIELD CORRECTIVE NOTICE

**GETINGE AQUADIS 56 – Frequency Inverter not programmed  
Field Action 1202136\_CAPA 1127926**

<b>Date:</b>	April 15, 2025
<b>Product Issue:</b>	GETINGE AQUADIS 56 – Frequency Inverter not programmed Field Action 1202136_CAPA 1127926 Field Action Plan GD13822
<b>Affected Product:</b>	Washer Disinfector Getinge Aquadis 56 of model number 56M and 56A
<b>UDI DI</b>	73401537000484
<b>SRN</b>	SE-MF-000001012
<b>Resolution:</b>	Getinge propose to rework the units which does not have a programmed Frequency Inverter, by replacing the memory module inside the frequency Inverter, to make sure all devices present in the market perform as intended and are working effectively.
<b>Affected Serial Nos.:</b>	All units manufactured between the release of the machine model 2022 until 30 <sup>th</sup> August 2024. Serial numbers of affected units can be found in Appendix 1.
<b>Field Correction Notice:</b>	This correction is triggered to prevent a possible failure of the device. The failure is related to that a component can wear and tear earlier than expected. The unit is safe to use, and you do not have to undertake any preventive actions

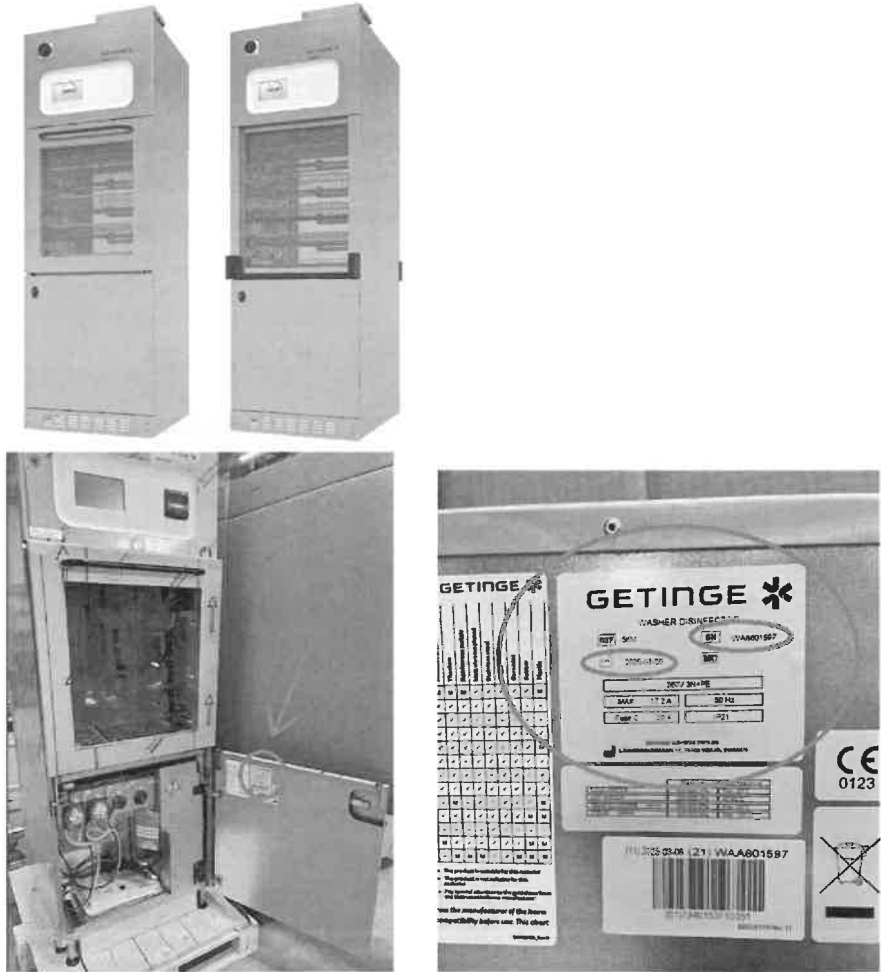
1. Check the serial number of the Washer Disinfector Aquadis 56. The serial number (WAAxxxxxx) shall correspond with the serial number on the customer response form (Appendix 1). The serial number can be found on the marking label, located on the inside of the lower door, see below.
